Elektromagnetisk metod ska rädda rörsystemen

Electromagnetic Method To Rescue the Plumbing

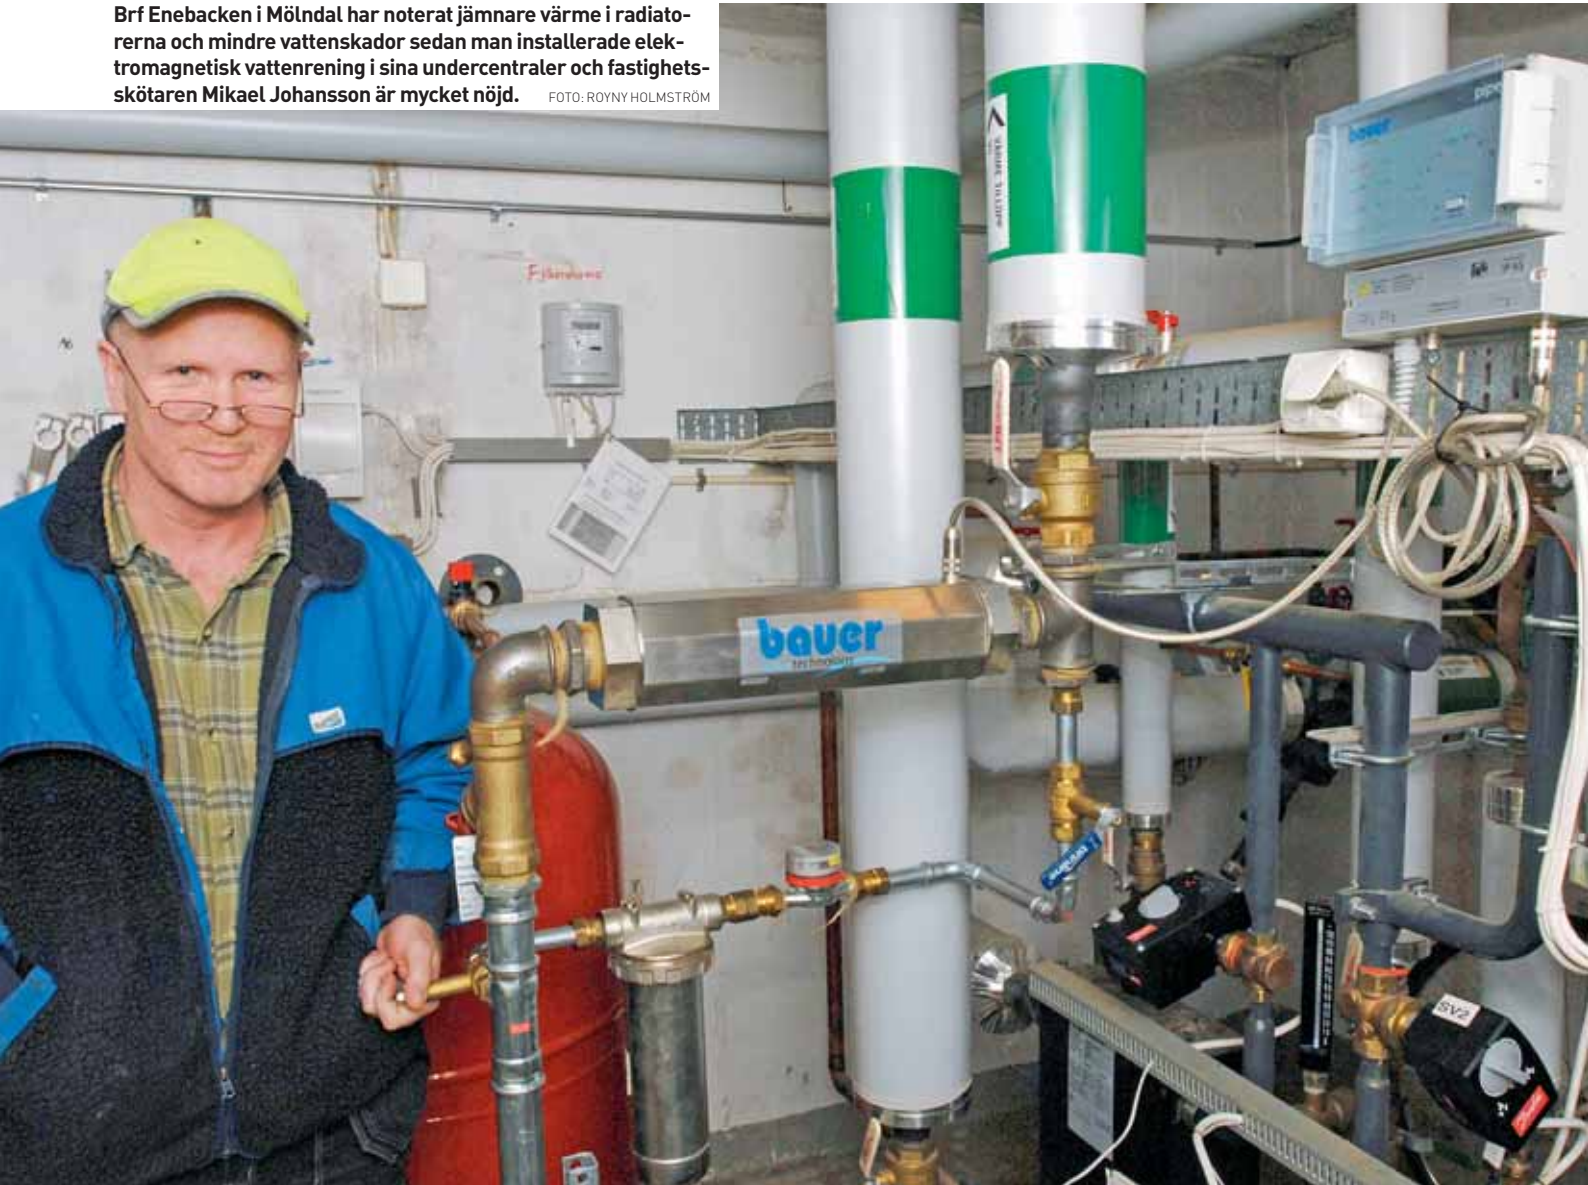
Brf Enebacken i Mölndal har noterat jämnare värme i radiatorerna och mindre vattenskador sedan man installerade elektromagnetisk vattenrening i sina undercentraler och fastighets-skötaren Mikael Johansson är mycket nöjd. FOTO: ROYNY HOLMSTRÖM

Problemen löste sig 2008 efter att man installerat elektromagnetisk vattenbehandling i samtliga undercentraler. Man kunde även reducera vattentryck och flöde i både värme- och vattenledningar och problemet med vattenskadorna upphörde.

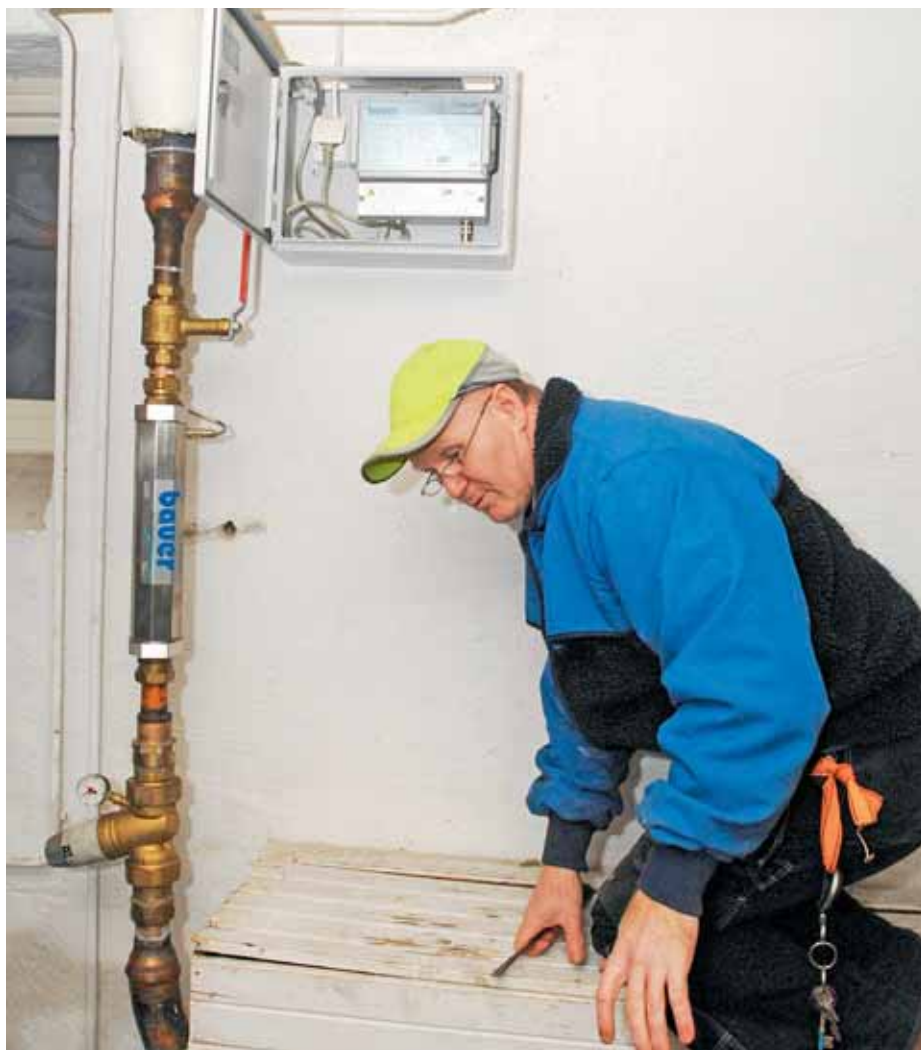
För att komma till rätta med ständigt återkommande vattenskadorna har man i Mölndal installerat reduceringsventiler tillsammans med vattenreningen. Trycket reduceras från cirka 7–8 bar till cirka 4–5 bar.

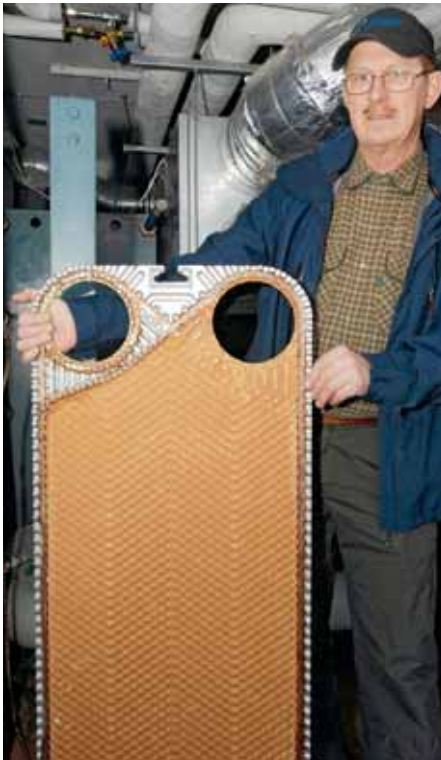
– Så här såg plåtarna ut i värmeväxlaren tidigare. De måste rengöras med jämna mellanrum – cirka 3–4 gånger mellan 1986 till 2008, berättar vicevärden Stig Kyldén i Skövde.

– I början hade vi stora problem med kalk- och järnavlagringar i plattvärmväxlaren.

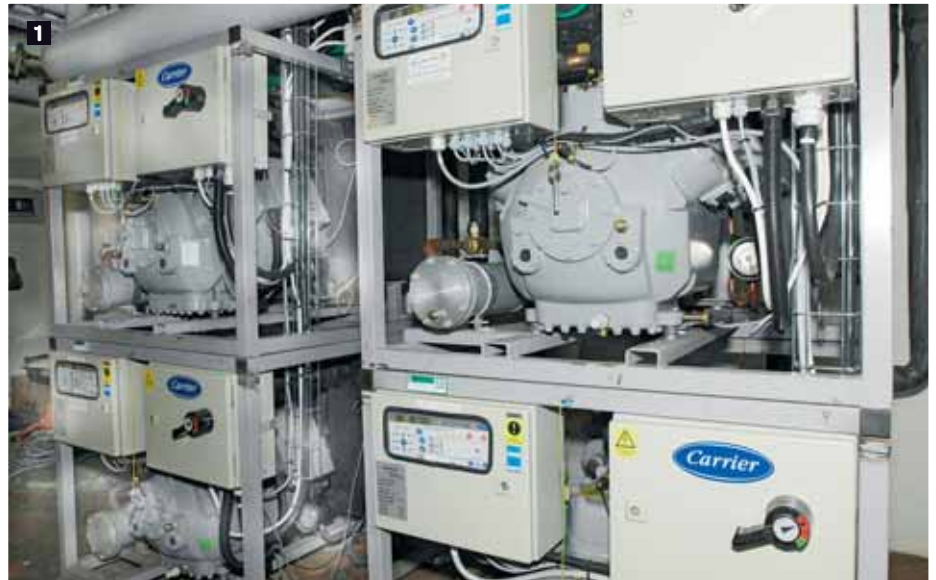
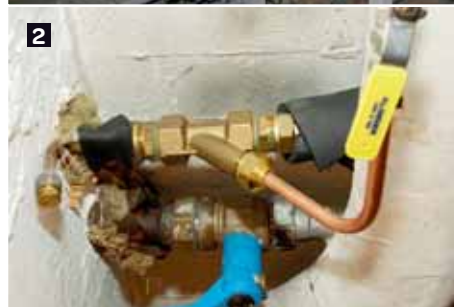
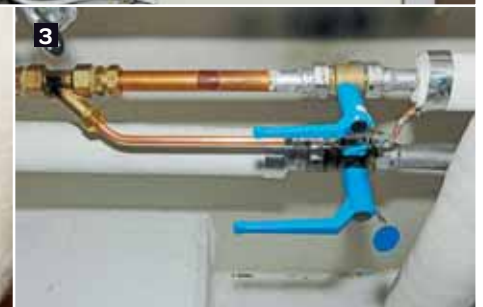
1. HSB Brf Dalsslätten valde alternativet värmepumpar när Skövde kommun aviserade en kraftig ökning av fjärrvärmesaxan. Ett beslut som man inte ångrar. Det har vi tjänat in flera gånger om, säger vicevärden Stig Kyldén. **2.** Här har man bytt ut den tidigare ledningen för varmvatten cirkulation mot ett system integrerat med varmvattenledningen via en speciell ventil. **3.** Ytterligare ett exempel där man har kopplat ihop en yttre ledning med varmvattencirkulation med en inre via en speciell ventil.

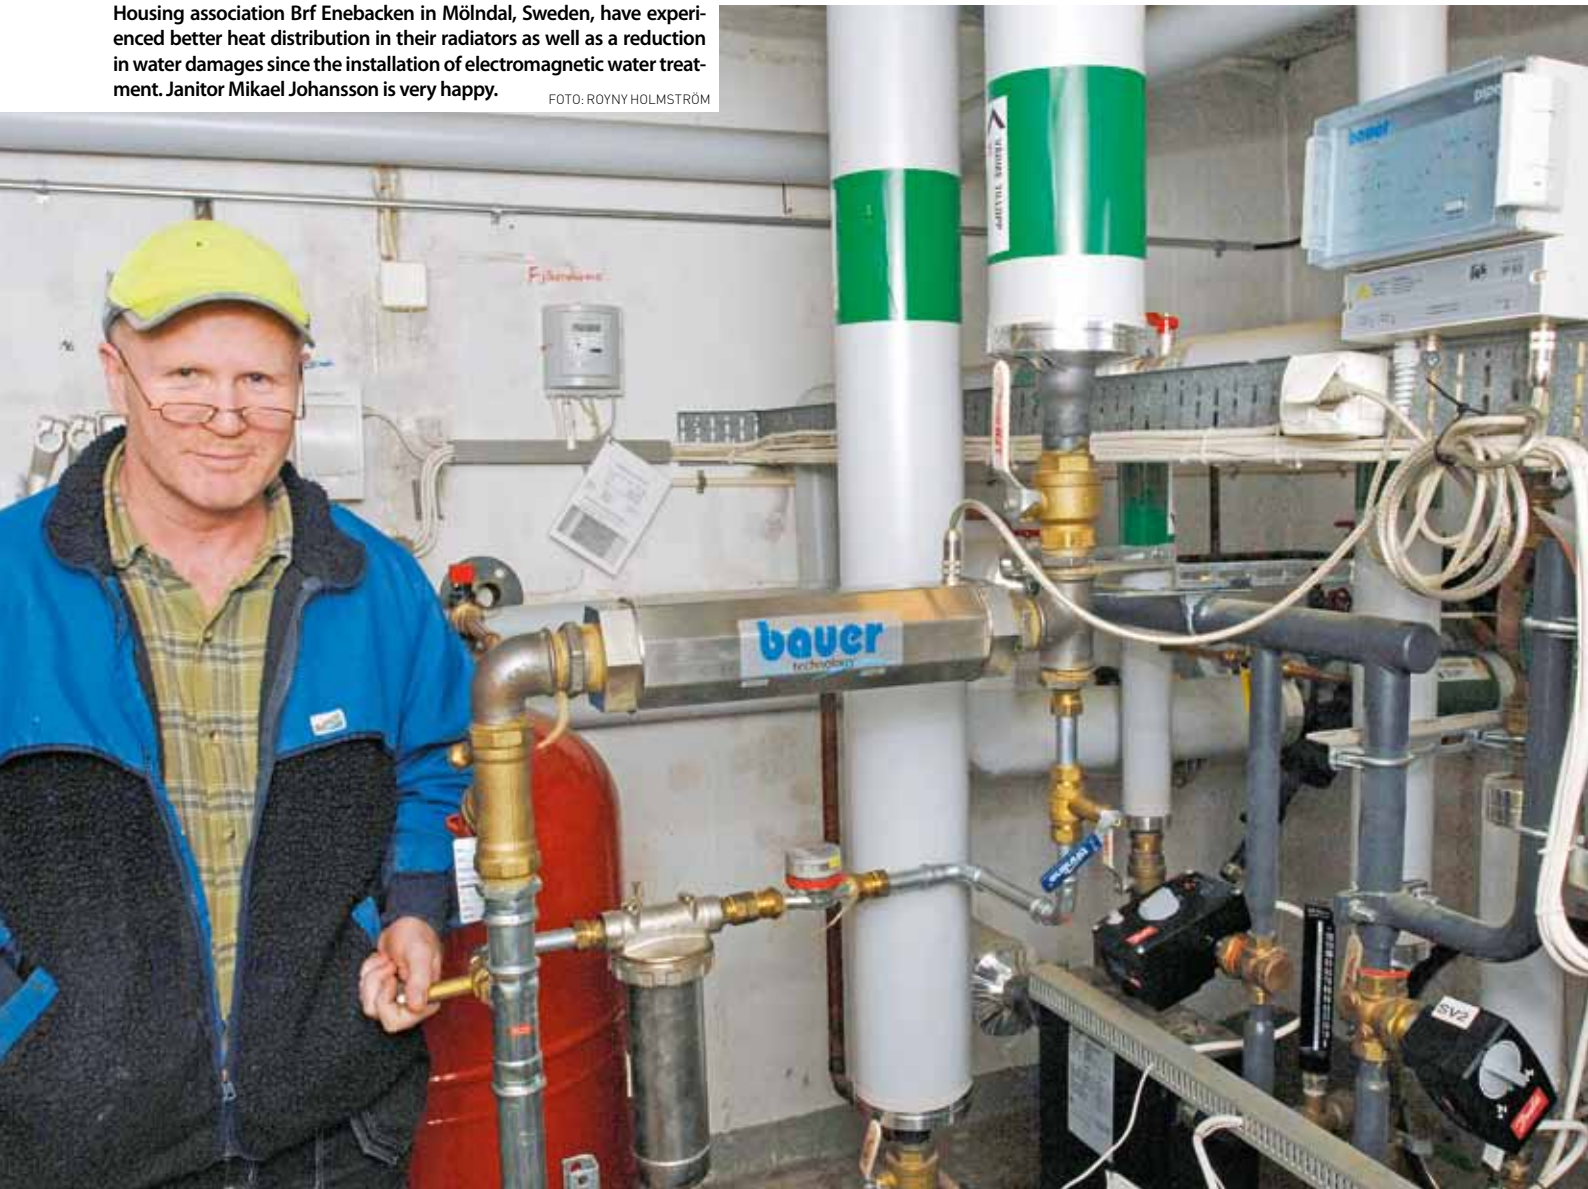
Housing association Brf Enebacken in Mölndal, Sweden, have experienced better heat distribution in their radiators as well as a reduction in water damages since the installation of electromagnetic water treatment. Janitor Mikael Johansson is very happy.

The problems disappeared after the installation of the electromagnetic water treatment units in all of their buildings in 2008. Both the pressure and flow rate could be lowered in the heating and tap water systems and there have been no sign of water damages ever since.

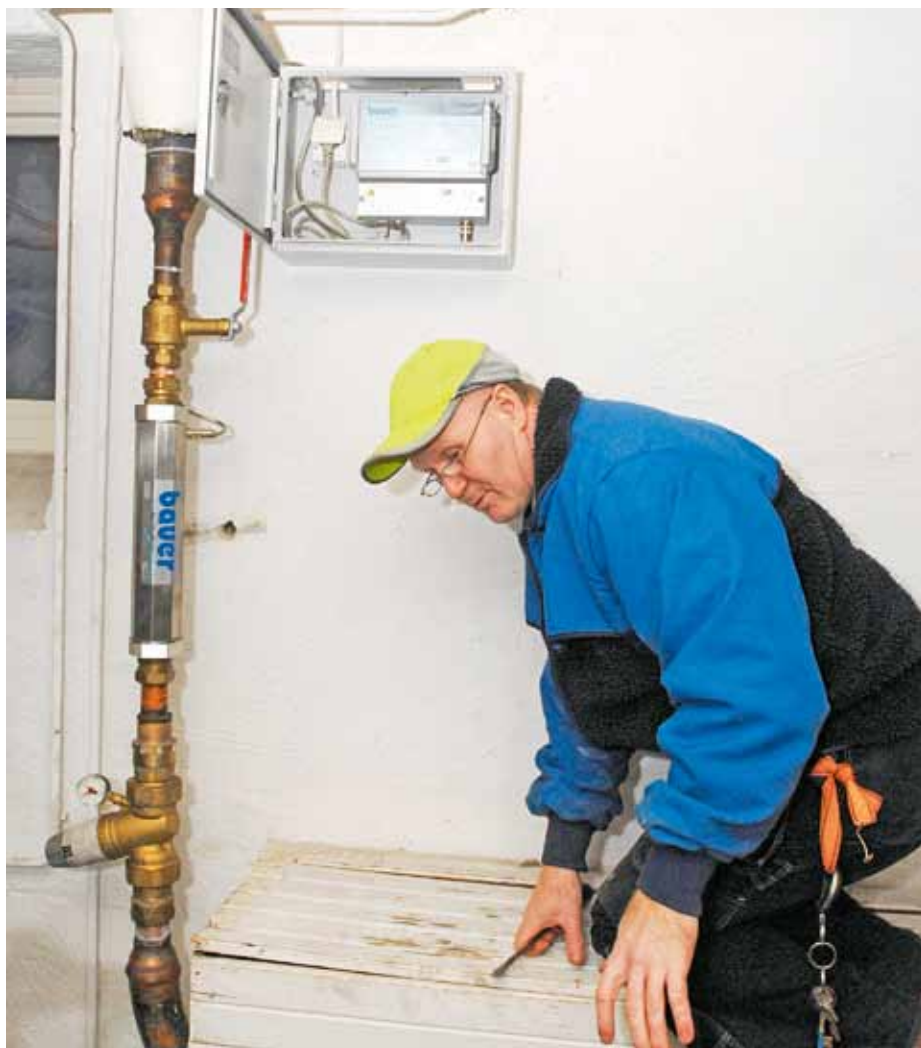
In order to overcome the repeatedly recurring water damages, the housing association in Mölndal decided to install pressure reducing valves concurrently with the water treatment devices. The water pressure is reduced from ca. 7-8 bar down to about 4-5 bar.

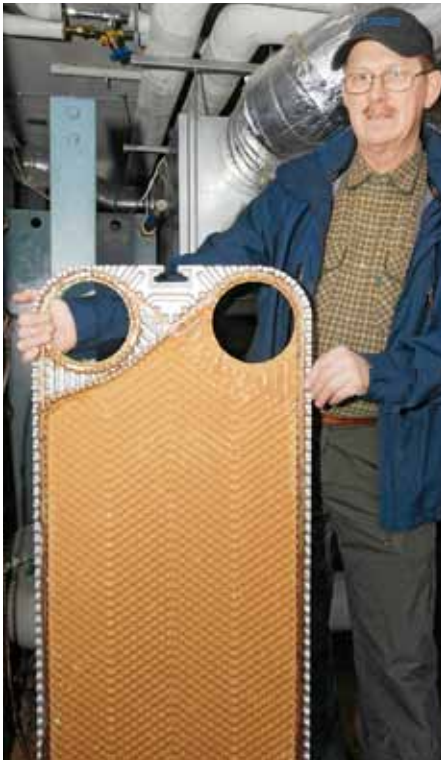
– This is how the plates of the heat exchanger used to look like. They had to be cleaned regularly – in total 3-4 times between 1986-2008, describes Stig Kyldén, vice chair of the housing association in Skövde.

– In the beginning we had big problems in the form of limescale and iron layers in the plate heat exchanger.

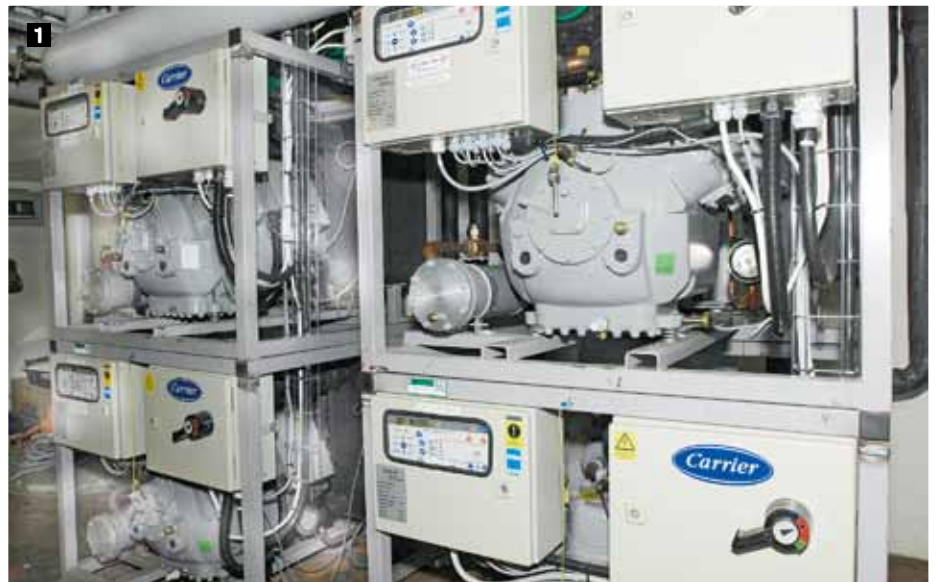
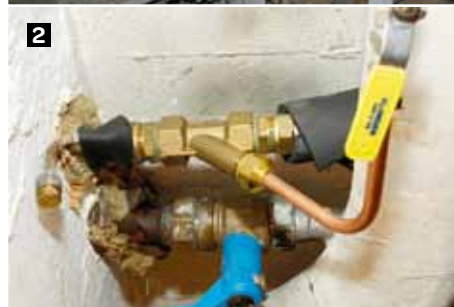
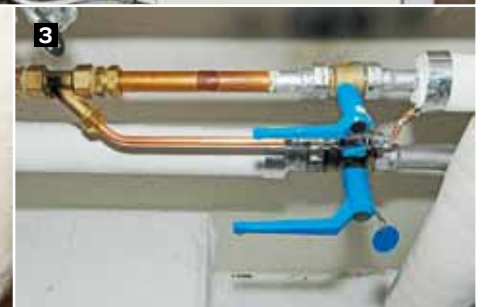
1. Brf Dalslätten chose heat pumps instead of district heating after the municipality announced a major increase of their DH tariffs. It was a decision they haven't regretted. The investment has already paid for itself many times over, reveals Stig Kyldén. **2.** Old pipe section of the DHW circulation has been replaced with a new one with the help of a special valve and coupling. **3.** Another example showing the connection of two separate DHW circulation pipes through a special valve.
